**Flood Control Project Maintenance
Levee Inspections****LMA District Cover Sheet****Spring 2015 Levee Inspection Results****Levee District No. 0003 (Glenn County)**

Levee Inspection Report By Mile - Spring 2015

Levee District No. 0003 (Glenn County)

Waterway	Bank	Unit Miles	Inspection Start/End	Inspector
Unit No. 01 Glenn County Sacramento River	Left	11.97	04/29/2015 04/29/2015	Bob Duffey

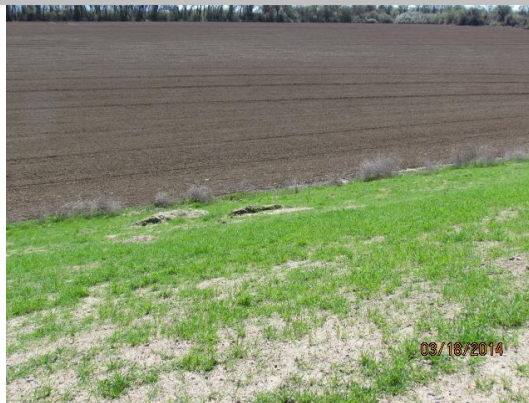
Photo 1 of 1 : SP_2015_LD0003_27_55_20150310_00024.jpg

LM Start	0.69	Rating **	M	Issue No.	55
LM End	0.69	Issue Type +	Ma	Location *	WS
Category	Earthen Levee			GPS Latitude/Longitude	
				Start	End
Item	Animal Control			39.388716 °	39.388716 °
				-121.997774 °	-121.997774 °
DWR ID	DWR_LD0003_01_s _ 2014_55				
Action/Comments					
Exterminate rodents and backfill and compact or grout burrows.

View of the rodent activity along the w/s slope.

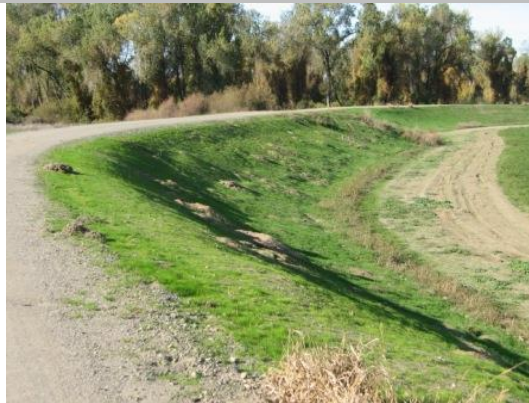
Photo 1 of 1 : SP_2015_LD0003_27_3_20150310_00002.jpg

LM Start	0.75	Rating **	M	Issue No.	3
LM End	0.75	Issue Type +	Ma	Location *	LS
Category	Earthen Levee			GPS Latitude/Longitude	
				Start	End
Item	Animal Control			39.388323 °	39.388323 °
				-121.998727 °	-121.998727 °
DWR ID	DWR_LD0003_01_s _ 2012_3				
Action/Comments					
No rodents visible, but rodent burrows visible; need to backfill and compact or grout burrows.

View of squirrel holes along the slope.

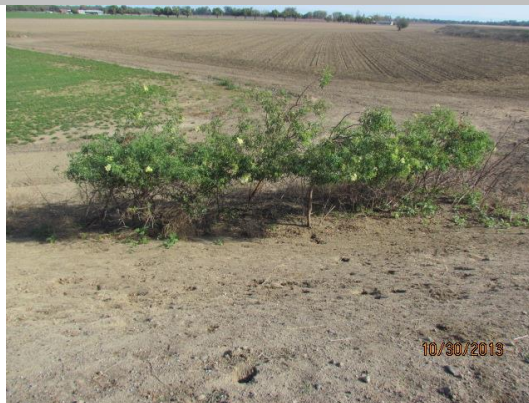
Photo 1 of 1 : SP_2015_LD0003_27_67_20150310_00032.jpg

LM Start	0.82	Rating **	M	Issue No.	67
LM End	0.82	Issue Type +	Ma	Location *	LS
Category	Earthen Levee			GPS Latitude/Longitude	
				Start	End
Item	Vegetation			39.388725 °	39.388725 °
				-121.999870 °	-121.999870 °
DWR ID	DWR_LD0003_01_f_2013_67				
Action/Comments					
Elderberries are blocking visibility and flood fight capability.

View of the elderberries along the landside toe.

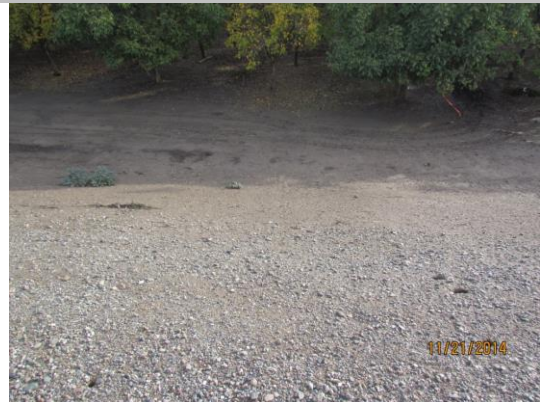
Photo 1 of 1 : SP_2015_LD0003_27_13_20150310_00008.jpg

View of the rodent holes along the waterside slope.

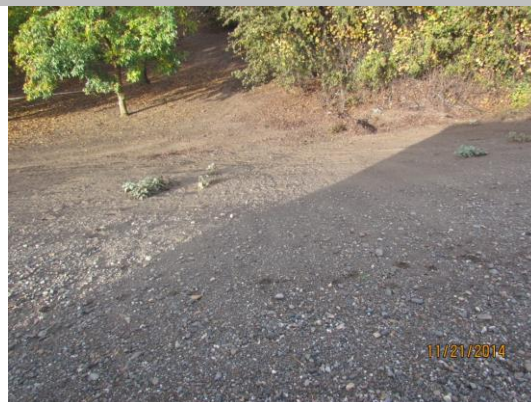
Photo 1 of 1 : SP_2015_LD0003_27_47_20150310_00021.jpg

View of the rodent holes along the waterside slope.

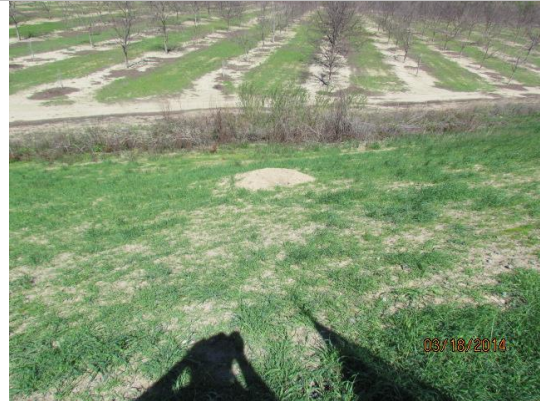
Photo 1 of 1 : SP_2015_LD0003_27_59_20150310_00025.jpg

View of the rodent activity along the w/s slope.

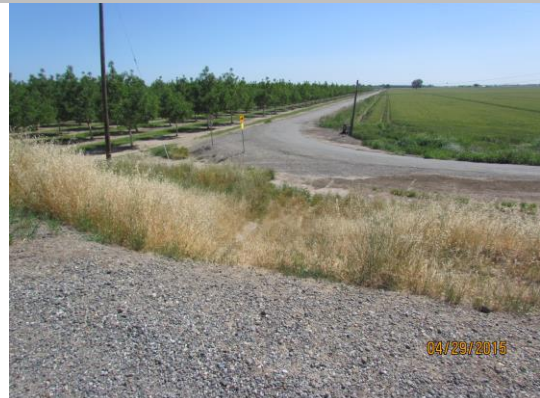
Photo 1 of 1 : SP_2015_LD0003_27_9_20150505_00048.jpg

LM Start	3.38	Rating **	M	Issue No.	9
LM End	3.38	Issue Type +	Ma	Location *	LS
Category	Earthen Levee			GPS Latitude/Longitude	
				Start	End
Item	Slope Stability			39.418267 °	39.418267 °
				-121.992472 °	-121.992472 °
DWR ID	DWR_LD0003_01_s_2012_9				
Action/Comments					
Repair the levee slope damaged by vehicle traffic and prevent access where possible.					
Inspector Comments: Repair the erosion along the landside slope.

View of the vehicle erosion along the landside slope.

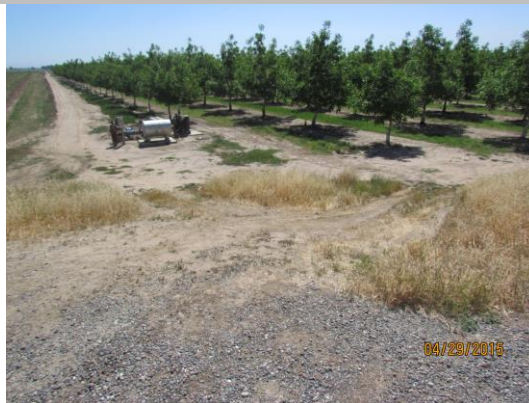
Photo 1 of 1 : SP_2015_LD0003_27_19_20150505_00049.jpg

LM Start	3.76	Rating **	M	Issue No.	19
LM End	3.76	Issue Type +	Ma	Location *	LS
Category	Earthen Levee			GPS Latitude/Longitude	
				Start	End
Item	Slope Stability			39.423747 °	39.423747 °
				-121.991667 °	-121.991667 °
DWR ID	DWR_LD0003_01_s_2012_19				
Action/Comments					
Repair the levee slope damaged by vehicle traffic and prevent access where possible.					
Inspector Comments: Repair the vehicle erosion on the landside slope.

View of the vehicle erosion along the landside slope.

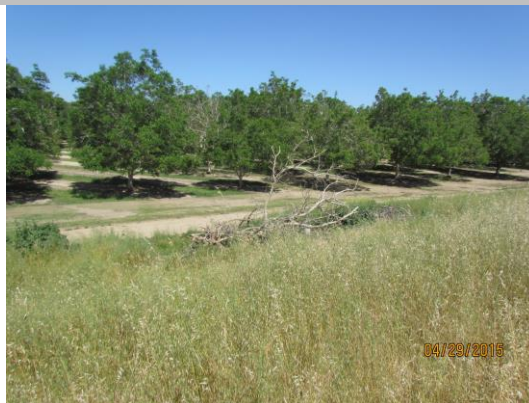
Photo 1 of 1 : SP_2015_LD0003_27_43_20150505_00050.jpg

LM Start	3.98	Rating **	M	Issue No.	43
LM End	3.98	Issue Type +	En	Location *	WS
Category	Earthen Levee			GPS Latitude/Longitude	
				Start	End
Item	Encroachments			39.426325 °	39.426325 °
				-121.989198 °	-121.989198 °
DWR ID	DWR_LD0003_01_s_2015_43				
Action/Comments					
Prunings					
Inspector Comments: Remove the prunings from the waterside slope.

View of the prunings along the waterside slope.

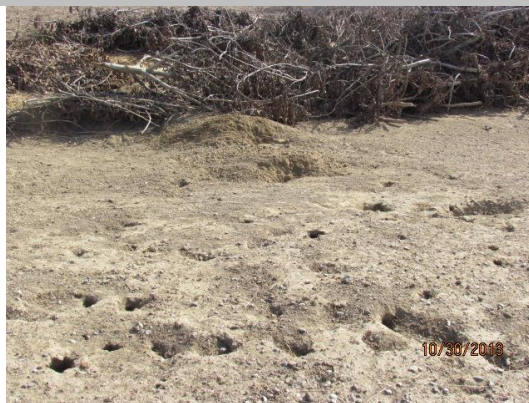
Photo 1 of 1 : SP_2015_LD0003_27_65_20150310_00031.jpg

LM Start	4.01	Rating **	M	Issue No.	65
LM End	4.01	Issue Type +	Ma	Location *	WS
Category	Earthen Levee			GPS Latitude/Longitude	
				Start	End
Item	Animal Control			39.426571 °	39.426571 °
				-121.988942 °	-121.988942 °
DWR ID	DWR_LD0003_01_f_2013_65				
Action/Comments					
No rodents visible, but rodent burrows visible; need to backfill and compact or grout burrows.

View of the rodent activity along the waterside slope.

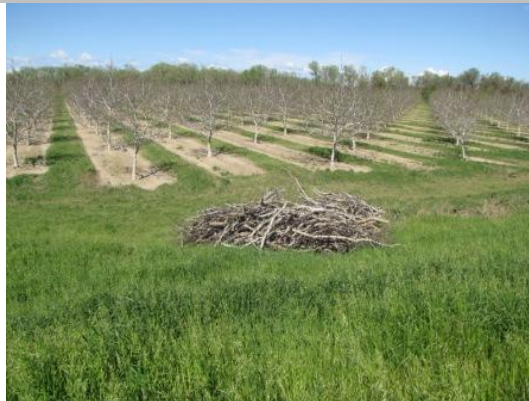
Photo 1 of 1 : SP_2015_LD0003_27_1_20150310_00001.jpg

View of prunings along the W/S toe.

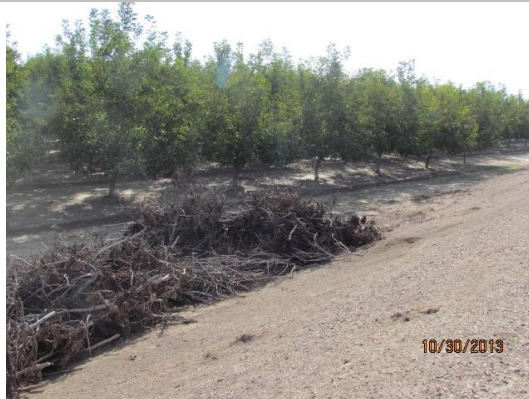
Photo 1 of 1 : SP_2015_LD0003_27_63_20150310_00029.jpg

LM Start	4.66	Rating **	M	Issue No.	63
LM End	4.66	Issue Type +	Ma	Location *	LS
Category	Earthen Levee			GPS Latitude/Longitude	
				Start	End
Item	Encroachments			39.435701 °	39.435701 °
				-121.988189 °	-121.988189 °
DWR ID	DWR_LD0003_01_f_2013_63				
Action/Comments					
Prunings

View of the prunings along the landside toe.

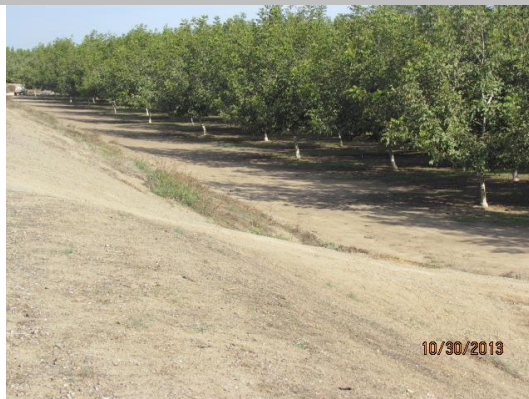
Photo 1 of 1 : SP_2015_LD0003_27_64_20150310_00030.jpg

LM Start	4.66	Rating **	M	Issue No.	64
LM End	4.66	Issue Type +	Ma	Location *	LS
Category	Earthen Levee			GPS Latitude/Longitude	
				Start	End
Item	Animal Control			39.435702 °	39.435702 °
				-121.988189 °	-121.988189 °
DWR ID	DWR_LD0003_01_f_2013_64				
Action/Comments					
No rodents visible, but rodent burrows visible; need to backfill and compact or grout burrows.

View of the rodent activity along the landside slope.

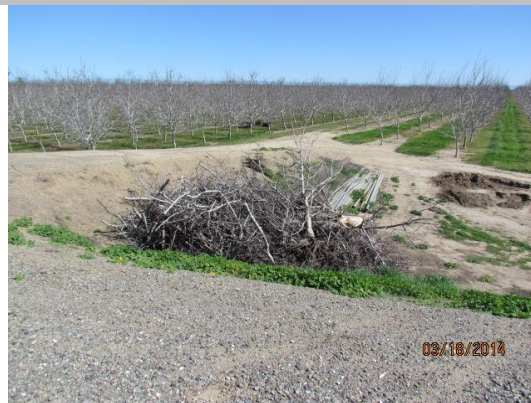
Photo 1 of 1 : SP_2015_LD0003_27_68_20150310_00033.jpg

View of the prunings along the l/s toe.

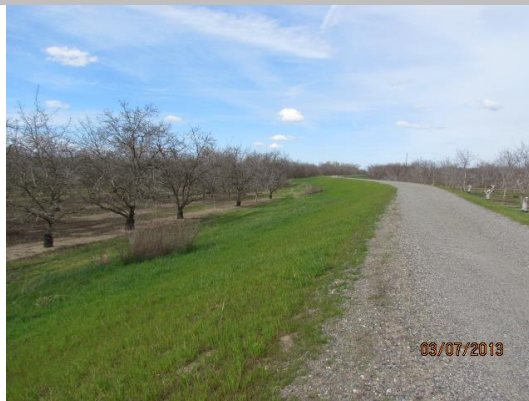
Photo 1 of 1 : SP_2015_LD0003_27_21_20150310_00011.jpg

View of no rodent activity.

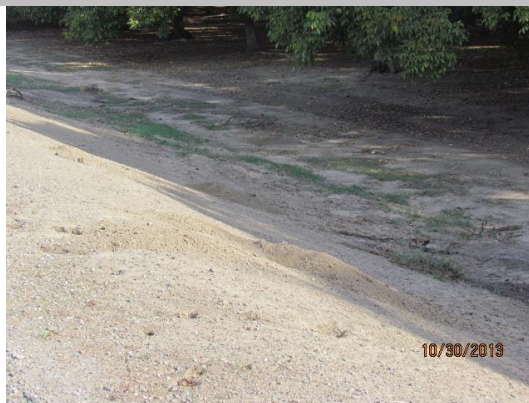
Photo 1 of 1 : SP_2015_LD0003_27_62_20150310_00028.jpg

LM Start	5.54	Rating **	M	Issue No.	62
LM End	5.66	Issue Type +	Ma	Location *	LS
Category	Earthen Levee			GPS Latitude/Longitude	
				Start	End
Item	Animal Control			39.447947 °	39.449739 °
				-121.991770 °	-121.991978 °
DWR ID	DWR_LD0003_01_f_2013_62				
Action/Comments					
No rodents visible, but rodent burrows visible; need to backfill and compact or grout burrows.

View of the rodent holes along the landside slope.

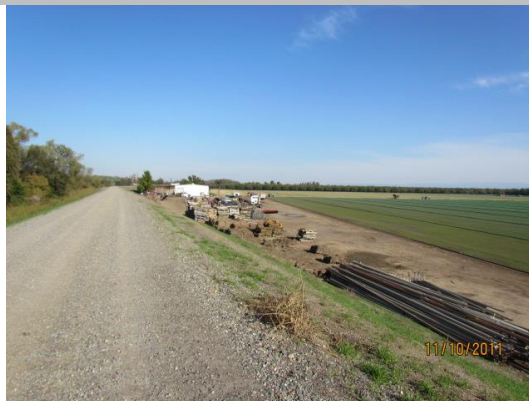
Photo 1 of 1 : SP_2015_LD0003_27_25_20150310_00012.jpg

LM Start	5.77	Rating **	M	Issue No.	25
LM End	5.88	Issue Type +	Ma	Location *	LS
Category	Earthen Levee			GPS Latitude/Longitude	
				Start	End
Item	Encroachments			39.451293 °	39.452872 °
				-121.992370 °	-121.992897 °
DWR ID	DWR_LD0003_01_s_2012_25				
Action/Comments					
Abandoned vehicles

View of the equipment along the L/S toe.

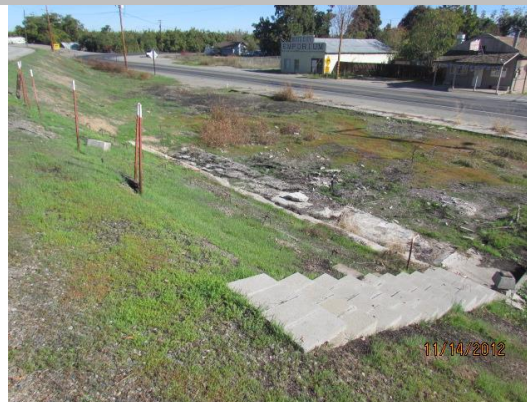
Photo 1 of 1 : SP_2015_LD0003_27_12_20150310_00007.jpg

LM Start	6.63	Rating **	M	Issue No.	12
LM End	6.63	Issue Type +	Ma	Location *	LS
Category	Earthen Levee			GPS Latitude/Longitude	
				Start	End
Item	Slope Stability			39.463366 °	39.463366 °
				-121.992586 °	-121.992586 °
DWR ID	DWR_LD0003_01_f _ 2012_12				
Action/Comments					
Repair slope instability.					
Inspector Comments: Building has burned down.

View of concrete stairs & foundation along the slope of the levee.

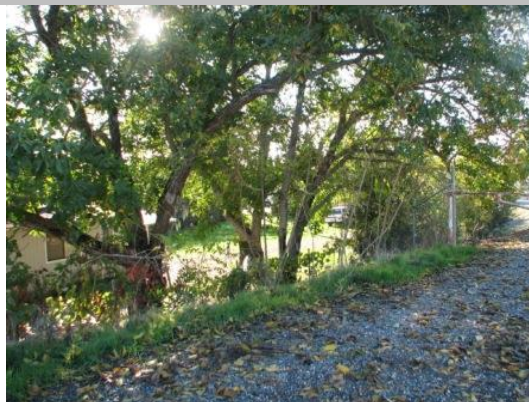
Photo 1 of 1 : SP_2015_LD0003_27_35_20150310_00018.jpg

View of the trees that are hanging over the landside slope of the levee.

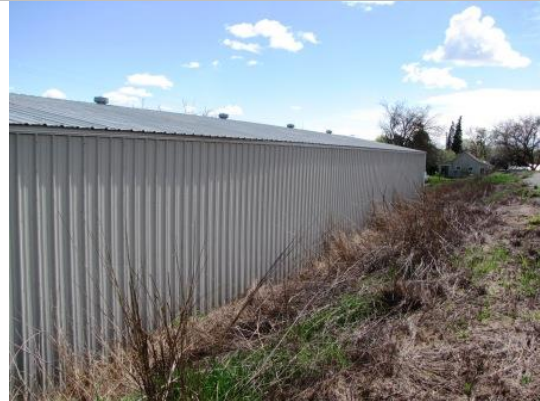
Photo 1 of 1 : SP_2015_LD0003_27_42_20150310_00020.jpg

View of the building along the L/S toe.

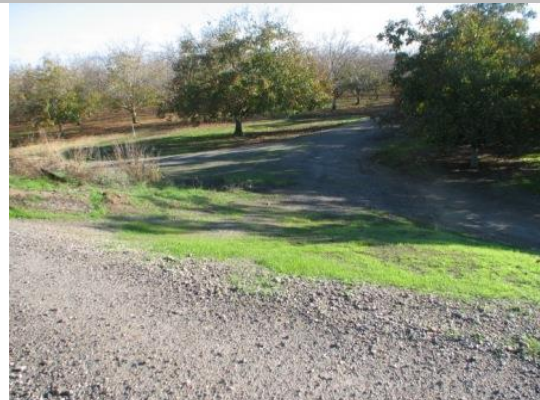
Photo 1 of 1 : SP_2015_LD0003_27_14_20150310_00009.jpg

LM Start	7.21	Rating **	M	Issue No.	14
LM End	7.21	Issue Type +	Ma	Location *	LS
Category	Earthen Levee			GPS Latitude/Longitude	
				Start	End
Item	Slope Stability			39.471658 °	39.471658 °
				-121.991245 °	-121.991245 °
DWR ID	DWR_LD0003_01_s _ 2012_14				
Action/Comments					
Repair the levee slope damaged by vehicle traffic and prevent access where possible.

Vehicle erosion along the slope.

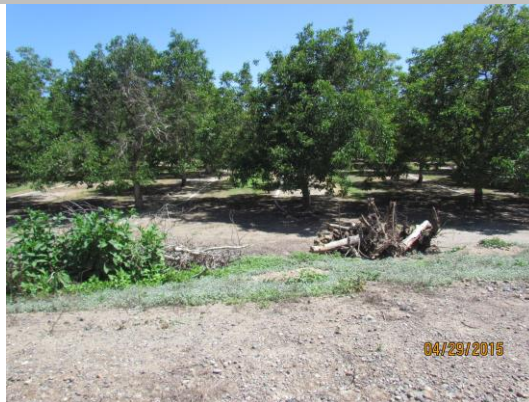
Photo 1 of 1 : SP_2015_LD0003_27_37_20150505_00051.jpg

View of the prunings along the landside slope.

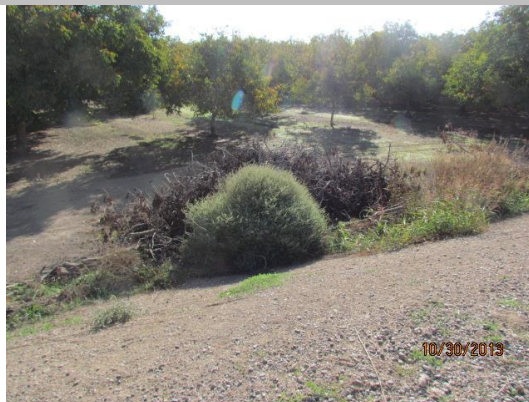
Photo 1 of 1 : SP_2015_LD0003_27_61_20150310_00027.jpg

LM Start	7.59	Rating **	M	Issue No.	61
LM End	7.59	Issue Type +	En	Location *	LS
Category	Earthen Levee			GPS Latitude/Longitude	
				Start	End
Item	Encroachments			39.477150 °	39.477150 °
				-121.991038 °	-121.991038 °
DWR ID	DWR_LD0003_01_f_2013_61				
Action/Comments					
Prunings

View of the pruning along the landside toe.

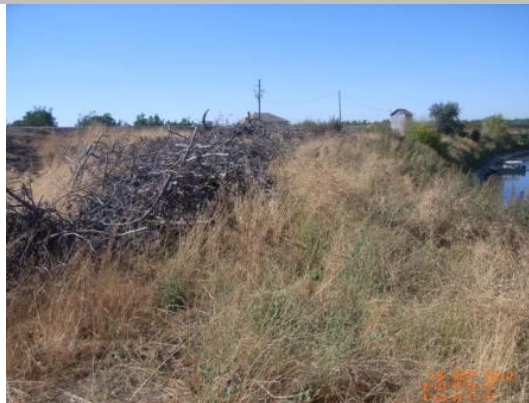
Photo 1 of 1 : SP_2015_LD0003_27_60_20150310_00026.jpg

View of the prunings along the landside toe.

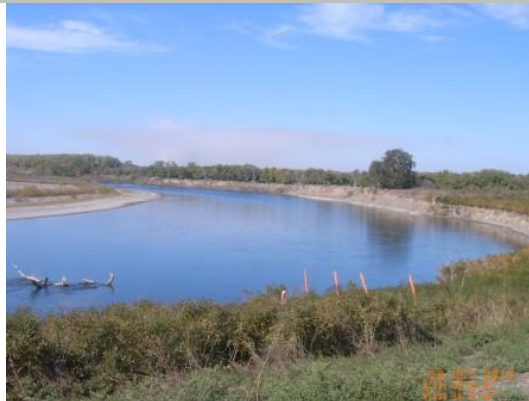
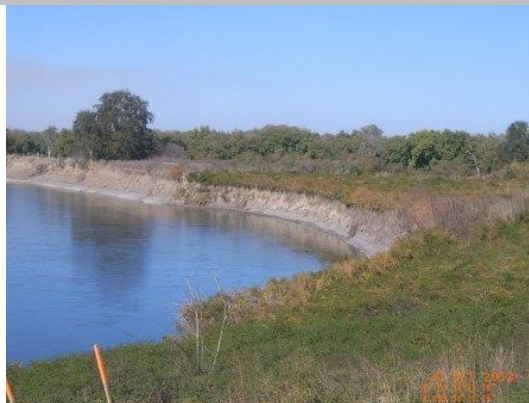
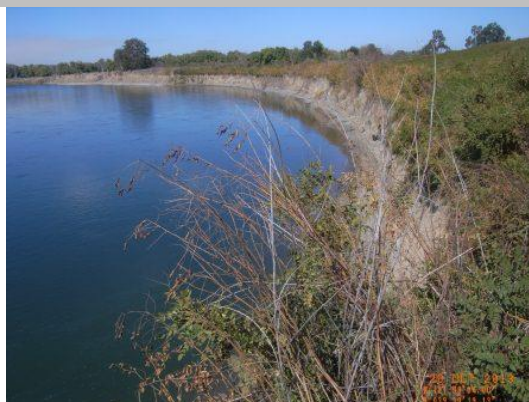
LM Start	8.71	Rating **	M	Issue No.	26
LM End	9.86	Issue Type +	Ma	Location *	WS
Category	Supplemental			GPS Latitude/Longitude	
				Start	End
Item	USACE Erosion Survey			39.508117 °	39.504388 °
				-121.986562 °	-121.985301 °
DWR ID	DWR_LD0003_01_f_2014_26				
Action/Comments					
Inspector Comments: 2007 - Getting close to the levee. Bank is clayey silt with clayey/silty toe. 2008 - Looks a little worse at the upstream end. 2009 - Some new erosion and slumping. 2010 - Some new erosion upstream of site, actively eroding at low flow. New bank swallow colony noted. 2011 - Significant erosion since last year, with an estimated 10 to 15 feet of berm lost. Large sections of the bank have slumped off. 2012 - Part of the site appears to be stabilizing, but still minor slumping in other locations. 2013: Minor new erosion at the toe. [2013 Site ID: SAC_172-0_L]

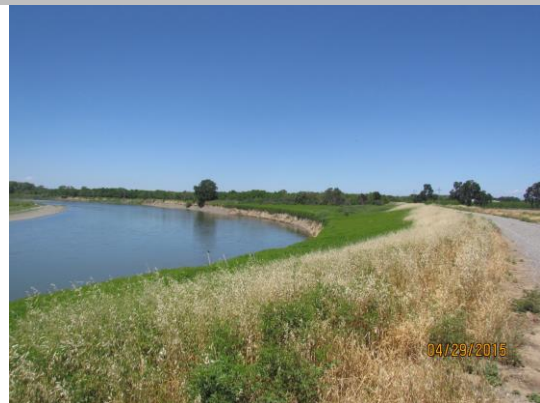
Photo 1 of 1 : SP_2015_LD0003_27_50_20150505_00052.jpg

LM Start	9.70	Rating **	U	Issue No.	50
LM End	9.70	Issue Type +	Ma	Location *	WS
Category	Earthen Levee			GPS Latitude/Longitude	
				Start	End
Item	Erosion / Bank Caving			39.505435 °	39.505435 °
				-121.984172 °	-121.984172 °
DWR ID	DWR_LD0003_01_f_2014_50				
Action/Comments					
Schedule repair of erosion site prior to the next inspection. Inspector Comments: The erosion site needs to be repaired.

View of erosion along the waterside toe. Same site as the USACE erosion issue.

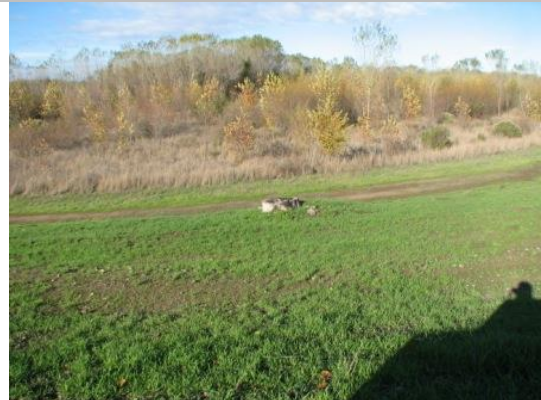
Photo 1 of 1 : SP_2015_LD0003_27_29_20150310_00016.jpg

View of the stump along the toe.

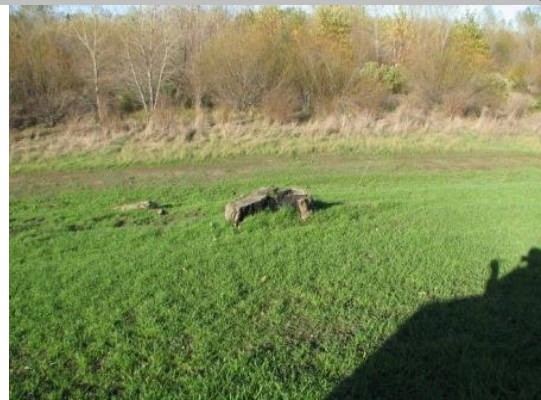
Photo 1 of 1 : SP_2015_LD0003_27_30_20150310_00017.jpg

LM Start	10.67	Rating **	N	Issue No.	30
LM End	10.67	Issue Type +	Ma	Location *	WS
Category	Earthen Levee			GPS Latitude/Longitude	
				Start	End
Item	Trim / Thin Trees			39.517715 °	39.517715 °
				-121.979155 °	-121.979155 °
DWR ID	DWR_LD0003_01_s_2012_30				
Action/Comments					
Tree stumps.

View of the stump along the slope.

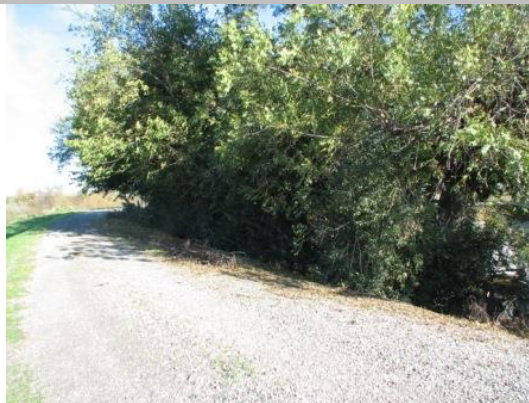
Photo 1 of 1 : SP_2015_LD0003_27_4_20150310_00003.jpg

View of the trees along the slope.
